**Flood Control Project Maintenance
Levee Inspections**
LMA District Cover Sheet
Spring 2016 Levee Inspection Results

Reclamation District No. 0017 Mossdale

Spring 2016 Levee Inspection Results

Waterway			Bank	Unit Miles
Unit No. 01 French Camp Slough			Left	1.76
	Spring (March - May)	Summer (June - August)	(September - November) Fall	Winter (December - February)
Unit Maintenance Rating (Fall Only)				
Date of Inspection	4/5/2016 - 4/5/2016			
DWR Inspector	Richard Willoughby			
Accompanied By	Robert Winter KSN

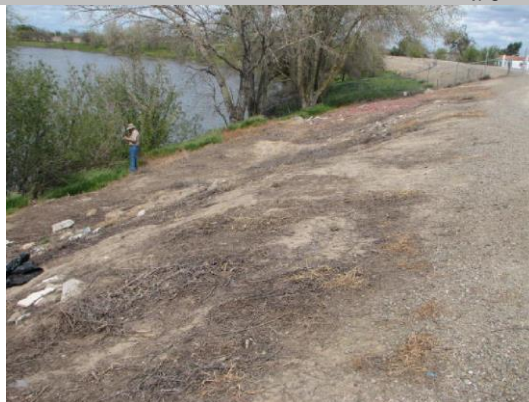
Photo 2 of 2 : UCIP_SP_2016_40695_72418.jpg

LM Start	11.31	Rating **	M	Issue No.	606
LM End	11.31	Issue Type +	En	Location *	LS
Category	Supplemental			GPS Latitude/Longitude	
				Start	End
Item	DWR UCIP Field Study			37.803410 °	37.803410 °
				-121.312031 °	-121.312031 °
DWR ID					
Comment Code					
Inspector Comment					
FS_ID:40695					
DS_ID:51					
EP_NO: 15055					
Repair Type: Non-Urgent					
Crossing Status: Found					
UCIP Comments: Pipe is not connected on waterward side. Crossing is non-functional recommend contacting owner to determine status of crossing. If crossing is no longer used need to coordinate with CVFPB for proper abandonment.					
FIELD_STRUCT_DESC: 16 inch diameter pipe through levee. Invert pipe is 3.91 feet below levee crown. Siphon breaker on landward shoulder. Slant pump on waterward slope, standpipe located 11 feet from the landward toe. (Permit No. 15055-1989)					
FS Date: 2/4/2010

View of waterward side.

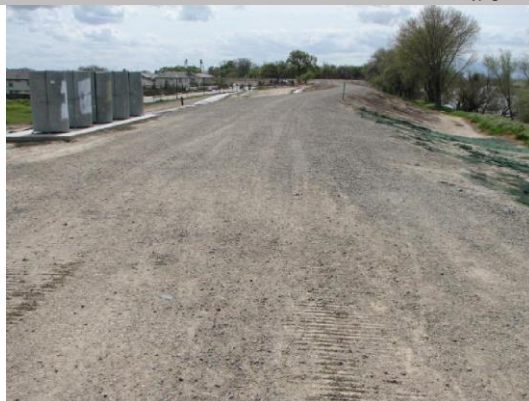
Photo 1 of 2 : UCIP_SP_2016_40696_72440.jpg

LM Start	11.35	Rating **	M	Issue No.	607
LM End	11.35	Issue Type +	En	Location *	LS
Category	Supplemental			GPS Latitude/Longitude	
				Start	End
Item	DWR UCIP Field Study			37.802921 °	37.802921 °
				-121.311947 °	-121.311947 °
DWR ID					
Comment Code					
Inspector Comment					
FS_ID:40696 DS_ID:103 EP_NO: 17792 Repair Type: Non-Urgent Crossing Status: Found UCIP Comments: Surface erosion on waterward slope--Need to contact owner. FIELD_STRUCT_DESC: 1 of 6. 30-inch diameter drainage pipe through levee at unknown depth. Struction is part of Lathrop City Stormwater Pump Station 112. Station consists 6 drainage pipes, pump station, air release valves, and concrete headwall. Air release valves located inside risers are located on landward shoulder on top of concrete pad. Concrete headwall and gates located on waterward side. (Permit No. 17792, 2005) FS Date: 2/4/2010

Overview of levee crown at crossing.

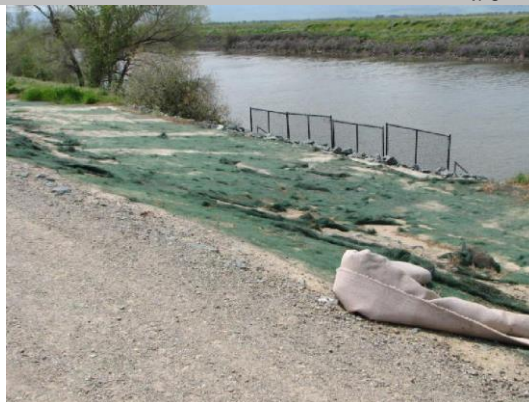
Photo 2 of 2 : UCIP_SP_2016_40696_72448.jpg

View of waterward side geotech fabric damage along slope.

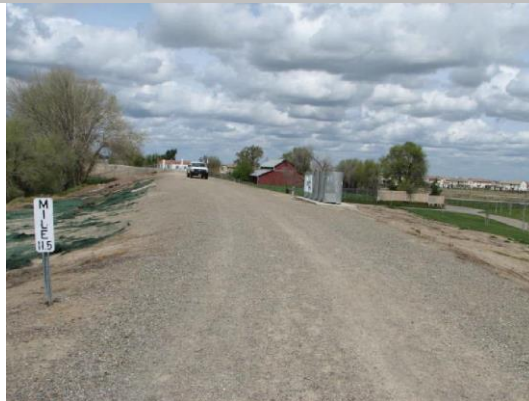
Photo 1 of 2 : UCIP_SP_2016_40697_72452.jpg

LM Start	11.35	Rating **	M	Issue No.	608
LM End	11.35	Issue Type +	En	Location *	LS
Category	Supplemental			GPS Latitude/Longitude	
				Start	End
Item	DWR UCIP Field Study			37.802904 °	37.802904 °
				-121.311946 °	-121.311946 °
DWR ID					
Comment Code					
Inspector Comment					
FS_ID:40697 DS_ID:473 EP_NO: 17792 Repair Type: Non-Urgent Crossing Status: Found UCIP Comments: Surface erosion on waterward slope--need to contact owner. FIELD_STRUCT_DESC: 2 of 6. 30-inch diameter drainage pipe through levee at unknown depth. Struction is part of Lathrop City Stormwater Pump Station 112. Station consists 6 drainage pipes, pump station, air release valves, and concrete headwall. Air release valves located inside risers are located on landward shoulder on top of concrete pad. Concrete headwall and gates located on waterward side. (Permit No. 17792, 2005) FS Date: 2/4/2010

Overview of levee crown at crossings.

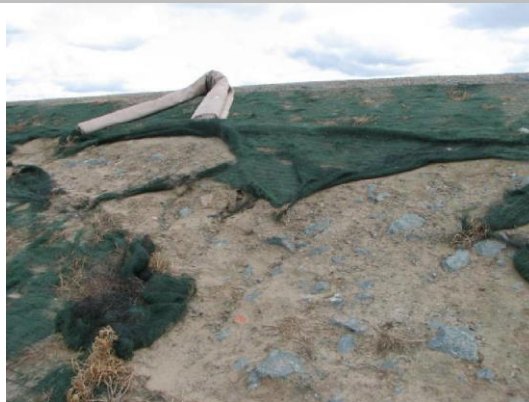
Photo 2 of 2 : UCIP_SP_2016_40697_72453.jpg

Geotech fabric damage along waterward berm.

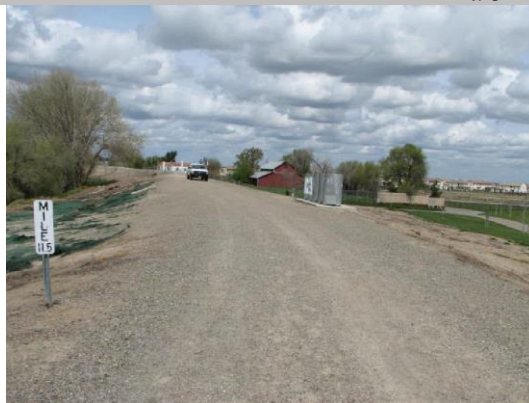
Photo 1 of 2 : UCIP_SP_2016_40698_72475.jpg

LM Start	11.35	Rating **	M	Issue No.	609
LM End	11.35	Issue Type +	En	Location *	LS
Category	Supplemental			GPS Latitude/Longitude	
				Start	End
Item	DWR UCIP Field Study			37.802889 °	37.802889 °
				-121.311947 °	-121.311947 °
DWR ID					
Comment Code					
Inspector Comment					
FS_ID:40698 DS_ID:474 EP_NO: 17792 Repair Type: Non-Urgent Crossing Status: Found UCIP Comments: Surface erosion on waterward slope--need to contact owner. FIELD_STRUCT_DESC: 3 of 6. 30-inch diameter drainage pipe through levee at unknown depth. Struction is part of Lathrop City Stormwater Pump Station 112. Station consists 6 drainage pipes, pump station, air release valves, and concrete headwall. Air release valves located inside risers are located on landward shoulder on top of concrete pad. Concrete headwall and gates located on waterward side. (Permit No. 17792, 2005) FS Date: 2/4/2010

Overview of levee crown at crossings.

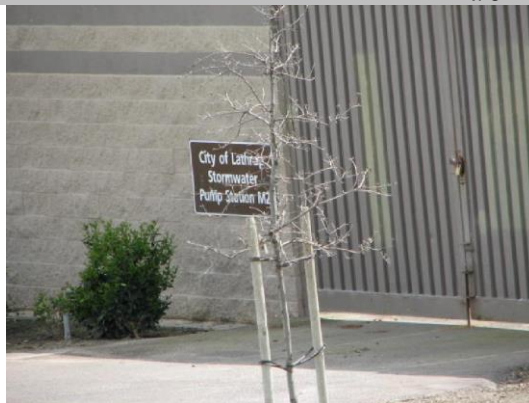
Photo 1 of 2 : UCIP_SP_2016_40699_72458.jpg

LM Start	11.35	Rating **	M	Issue No.	610
LM End	11.35	Issue Type +	En	Location *	LS
Category	Supplemental			GPS Latitude/Longitude	
				Start	End
Item	DWR UCIP Field Study			37.802869 °	37.802869 °
				-121.311948 °	-121.311948 °
DWR ID					
Comment Code					
Inspector Comment					
FS_ID:40699 DS_ID:475 EP_NO: 17792 Repair Type: Non-Urgent Crossing Status: Found UCIP Comments: Surface erosion on waterward slope--need to contact owner. FIELD_STRUCT_DESC: 4 of 6. 30-inch diameter drainage pipe through levee at unknown depth. Struction is part of Lathrop City Stormwater Pump Station 112. Station consists 6 drainage pipes, pump station, air release valves, and concrete headwall. Air release valves located inside risers are located on landward shoulder on top of concrete pad. Concrete headwall and gates located on waterward side. (Permit No. 17792, 2005) FS Date: 2/4/2010

City of Lathrop Stormwater Pump Station 112.

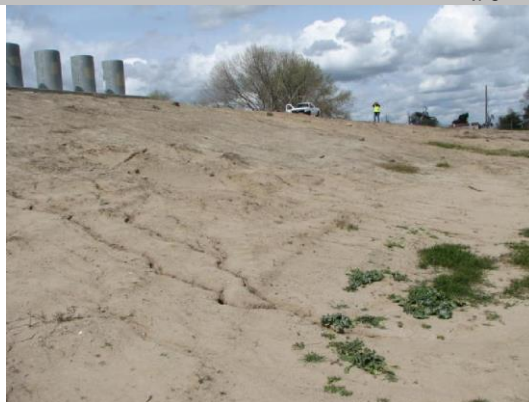
Photo 2 of 2 : UCIP_SP_2016_40699_72457.jpg

View of landward side.

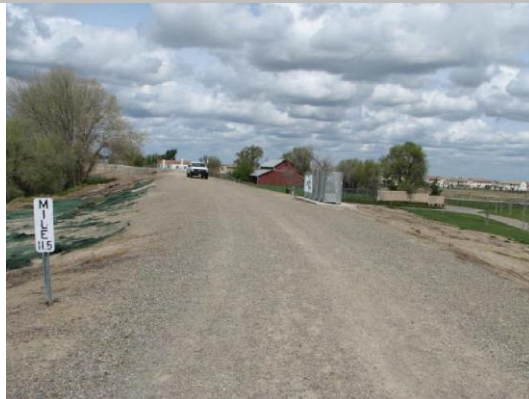
Photo 1 of 2 : UCIP_SP_2016_40701_72470.jpg

LM Start	11.35	Rating **	M	Issue No.	612
LM End	11.35	Issue Type +	En	Location *	LS
Category	Supplemental			GPS Latitude/Longitude	
				Start	End
Item	DWR UCIP Field Study			37.802837 °	37.802837 °
				-121.311949 °	-121.311949 °
DWR ID					
Comment Code					
Inspector Comment					
FS_ID:40701 DS_ID:477 EP_NO: 17792 Repair Type: Non-Urgent Crossing Status: Found UCIP Comments: Surface erosion on waterward slope--need to contact owner. FIELD_STRUCT_DESC: 6 of 6. 30-inch diameter drainage pipe through levee at unknown depth. Struction is part of Lathrop City Stormwater Pump Station 112. Station consists 6 drainage pipes, pump station, air release valves, and concrete headwall. Air release valves located inside risers are located on landward shoulder on top of concrete pad. Concrete headwall and gates located on waterward side. (Permit No. 17792, 2005) FS Date: 2/4/2010

Overview of levee crown at crossings.

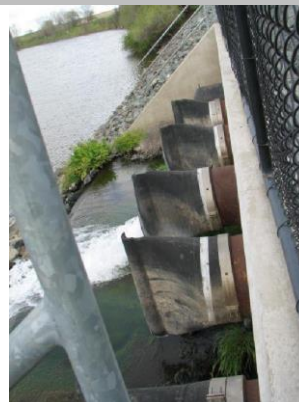
Photo 2 of 2 : UCIP_SP_2016_40701_72469.jpg

Outlet concrete headwall and gates on waterward toe.

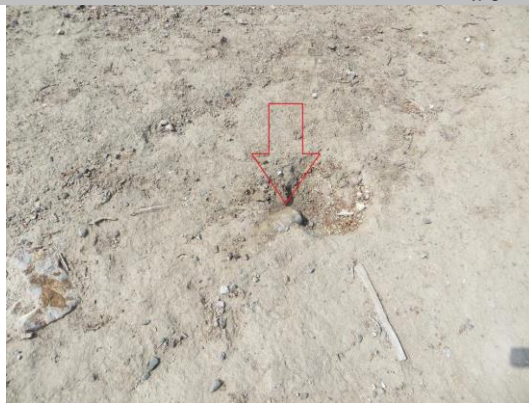
Photo 1 of 2 : UCIP_SP_2016_45463_74122.jpg

FS_ID:45463
DS_ID:53
EP_NO: 15125
Repair Type: Non-Urgent
Crossing Status: Indicator Found
UCIP Comments: Pipe appears abandoned as vent is partially buried and pipe not visible. If abandoned, it should be done so properly.
FIELD_STRUCT_DESC: 7 inch diameter pipe through the levee 3.59-feet below levee crown. Siphon breaker located on landward shoulder.
Air vent found on WS slope (Permit No. 15125-1989).
FS Date: 5/21/2015

Vent visible on WS slope. Found partially buried.

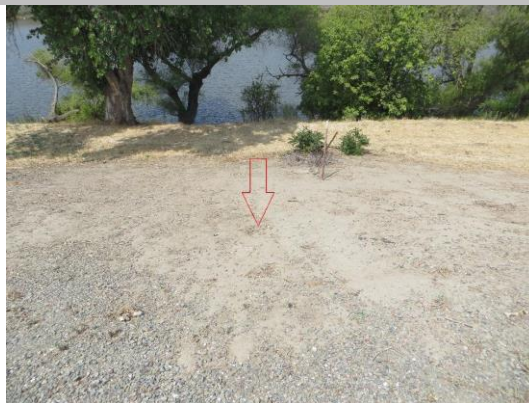
Photo 2 of 2 : UCIP_SP_2016_45463_74121.jpg

Vent visible on WS slope. Found partially buried.

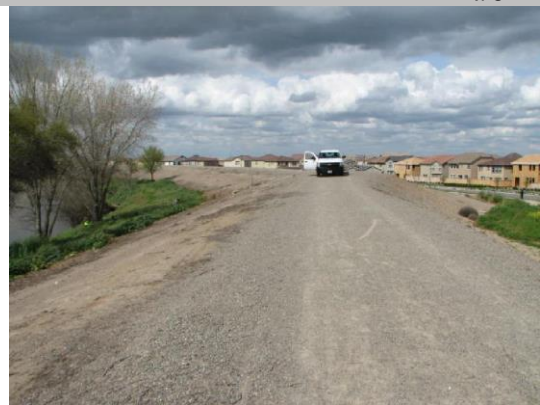
Photo 1 of 2 : UCIP_SP_2016_40702_72481.jpg

Comment Code					
Inspector Comment					
FS_ID:40702 DS_ID:806 EP_NO: N/A Repair Type: Non-Urgent Crossing Status: Found UCIP Comments: No pipe found during site visit only air valve and power meter. Dense vegetation along waterward slope recommend clearing vegetation from slope to conduct proper pipe inspection. If crossing is no longer in use owner will need to coordinate with DWR inspector and CVFPB to remove according to Title 23 requirements. FIELD_STRUCT_DESC: *REMOVED* 20-inch Steel drain pipe through the levee 5-feet below the crown. Siphon breaker in steel riser on WS shoulder and a flap gate on the WS toe Permit No. 3799, 1961. Pipe removed under Permit No. 15318, 1989. Drainage or Irrigation Structure referenced in O&M manual (HLM 12.16). (USACE O&M, 1963) FS Date: 2/4/2010

Overview of levee crown at crossing.

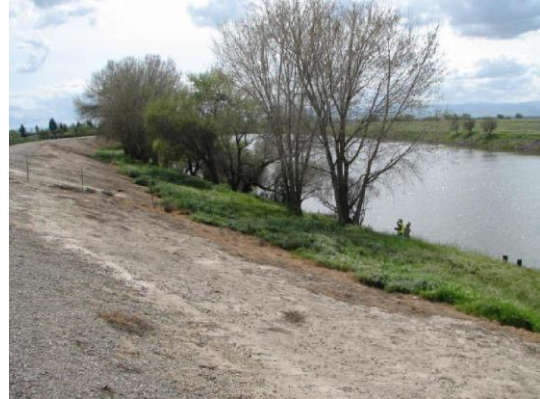
Photo 2 of 2 : UCIP_SP_2016_40702_72480.jpg

Item	DWR UCIP Field Study			37.793831 °	37.793831 °	
				-121.305989 °	-121.305989 °	
DWR ID						
Comment Code						
Inspector Comment						
FS_ID:40702						
DS_ID:806						
EP_NO: N/A						
Repair Type: Non-Urgent						
Crossing Status: Found						
UCIP Comments: No pipe found during site visit only air valve and power meter. Dense vegetation along waterward slope recommend clearing vegetation from slope to conduct proper pipe inspection. If crossing is no longer in use owner will need to coordinate with DWR inspector and CVFPB to remove according to Title 23 requirements.						
FIELD_STRUCT_DESC: *REMOVED* 20-inch Steel drain pipe through the levee 5-feet below the crown. Siphon breaker in steel riser on WS shoulder and a flap gate on the WS toe Permit No. 3799, 1961. Pipe removed under Permit No. 15318, 1989. Drainage or Irrigation Structure referenced in O&M manual (HLM 12.16). (USACE O&M, 1963)

View of waterward side.

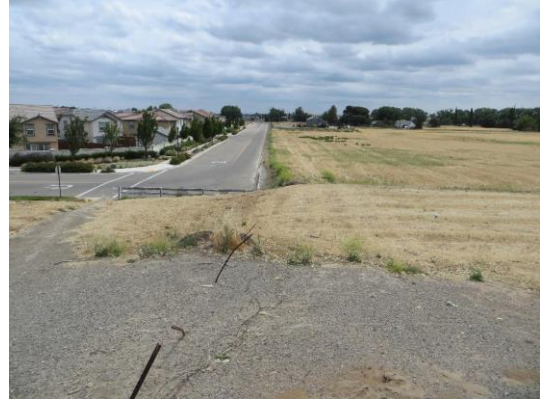
Photo 2 of 2 : UCIP_SP_2016_45464_74124.jpg

LM Start	12.14	Rating **	M	Issue No.	625 (cont)	
LM End	12.14	Issue Type +	En	Location *	LS	
Category	Supplemental			GPS Latitude/Longitude		
				Start	End	
Item	DWR UCIP Field Study			37.793831 °	37.793831 °	
				-121.305989 °	-121.305989 °	
DWR ID						
Comment Code						
Inspector Comment						
FS_ID:45464 DS_ID:56 EP_NO: 15318 Repair Type: Non-Urgent Crossing Status: Indicator Found UCIP Comments: Crossings appears to be abandoned. Need to contact owner to determine status of crossing. If abandoned, it should be done so properly. FIELD_STRUCT_DESC: 20 inch diameter steel storm drain discharge pipeline through levee 3.4-feet below levee crown. Air vent in 12-inch steel riser found on the landward shoulder. Electric service riser on waterward berm has been removed, Permit No. 15318, 1989. FS Date: 5/21/2015

View of LS at crossing.

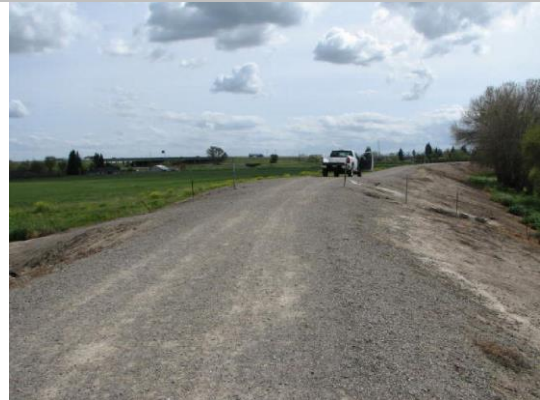
Photo 1 of 2 : UCIP_SP_2016_40703_72487.jpg

LM Start	12.14	Rating **	M	Issue No.	571
LM End	12.14	Issue Type +	En	Location *	LS
Category	Supplemental			GPS Latitude/Longitude	
				Start	End
Item	DWR UCIP Field Study			37.793779 °	37.793779 °
				-121.305984 °	-121.305984 °
DWR ID					
Comment Code					
Inspector Comment					
FS_ID:40703					
DS_ID:799					
EP_NO: N/A					
Repair Type: Non-Urgent					
Crossing Status: Found					
UCIP Comments: Need to contact owner to determine status of crossing and obtain additional information about crossing (permit and install date).					
FIELD_STRUCT_DESC: 1 of 2. 48-inch steel drainage pipe through the levee 2.5-feet below the crown. Siphon breaker on LS shoulder. Concrete "U" shaped headwall on WS toe with flap gate (Permit No. 15845, 1993). 8-4 inch steel coated scheduled 40 pipes located on waterward shoulder about 6 inch cover.					
FS Date: 2/4/2010

Overview of levee crown at crossings.

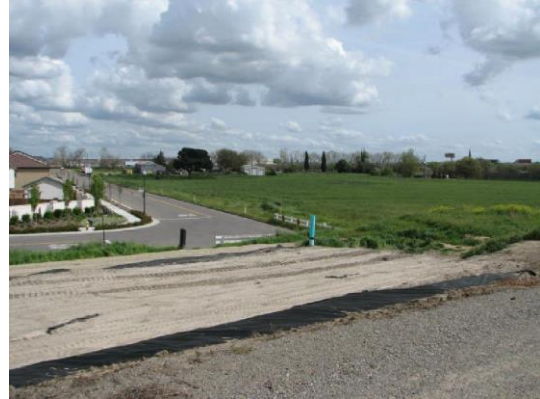
Photo 2 of 2 : UCIP_SP_2016_40703_72485.jpg

LM Start	12.14	Rating **	M	Issue No.	571 (cont)	
LM End	12.14	Issue Type +	En	Location *	LS	
Category	Supplemental			GPS Latitude/Longitude		
				Start	End	
Item	DWR UCIP Field Study			37.793779 °	37.793779 °	
				-121.305984 °	-121.305984 °	
DWR ID						
Comment Code						
Inspector Comment						
FS_ID:40703						
DS_ID:799						
EP_NO: N/A						
Repair Type: Non-Urgent						
Crossing Status: Found						
UCIP Comments: Need to contact owner to determine status of crossing and obtain additional information about crossing (permit and install date).						
FIELD_STRUCT_DESC: 1 of 2. 48-inch steel drainage pipe through the levee 2.5-feet below the crown. Siphon breaker on LS shoulder. Concrete "U" shaped headwall on WS toe with flap gate (Permit No. 15845, 1993). 8-4 inch steel coated scheduled 40 pipes located on waterward shoulder about 6 inch cover.						
FS Date: 2/4/2010

View of landward side, photo 1 of 2.

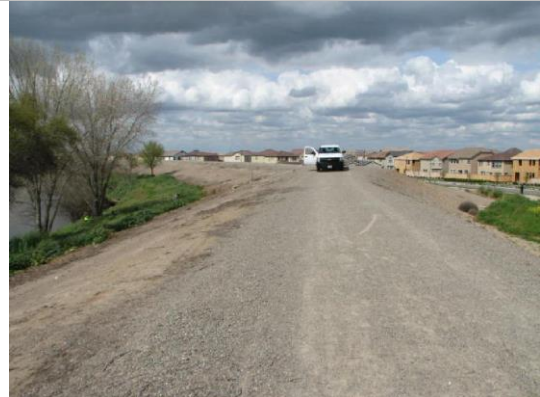
Photo 1 of 2 : UCIP_SP_2016_45993_72497.jpg

LM Start	12.14	Rating **	M	Issue No.	615
LM End	12.14	Issue Type +	En	Location *	LS
Category	Supplemental			GPS Latitude/Longitude	
				Start	End
Item	DWR UCIP Field Study			37.793766 °	37.793766 °
				-121.305986 °	-121.305986 °
DWR ID					
Comment Code					
Inspector Comment					
FS_ID:45993 DS_ID:800 EP_NO: 15845 Repair Type: Non-Urgent Crossing Status: Found UCIP Comments: Need to contact owner to determine status of crossing and obtain additional information about crossing (permit and install date). FIELD_STRUCT_DESC: 2 of 2. 12 inch drainage pipe through levee at unknown depth. Concrete "U" wall located on waterward side. Flap gate on waterward side. 8-4 inch steel coated scheduled 40 pipes located on waterward shoulder about 6 inch cover. Seepage berm located on landward side. FS Date: 2/4/2010

Overview of levee crown at crossing.

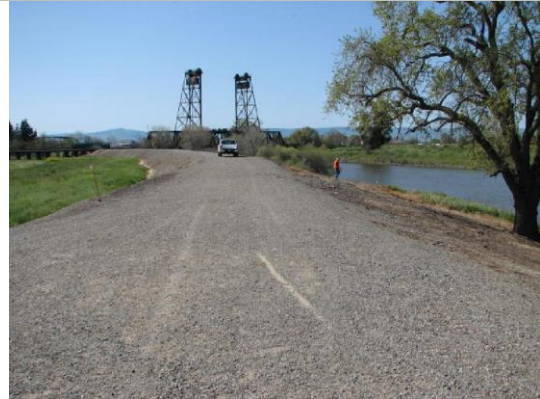
Photo 1 of 2 : UCIP_SP_2016_40706_72509.jpg

LM Start	12.41	Rating **	M	Issue No.	572
LM End	12.41	Issue Type +	En	Location *	LS
Category	Supplemental			GPS Latitude/Longitude	
				Start	End
Item	DWR UCIP Field Study			37.789976 °	37.789976 °
				-121.306853 °	-121.306853 °
DWR ID					
Comment Code					
Inspector Comment					
FS_ID:40706 DS_ID:807 EP_NO: N/A Repair Type: Non-Urgent Crossing Status: Found UCIP Comments: Pipe disconnected on waterward side. Need to contact owner to determine status of crossing. If crossing is no longer in use owner will need to coordinate with DWR inspector and CVFPB to remove according to Title 23 requirements. FIELD_STRUCT_DESC: 8 inch pipe through levee 3.2-feet below the crown. Pump on WS toe and a siphon breaker on the LS shoulder (Permit No. 15049, 1989). Permit was for 6-inch pipe. FS Date: 2/4/2010

Overview of levee crown at crossing.

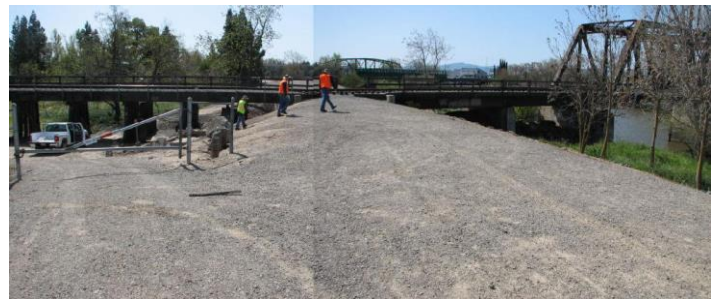
Photo 1 of 2 : UCIP_SP_2016_40707_72515.jpg

LM Start	12.55	Rating **	M	Issue No.	573
LM End	12.55	Issue Type +	En	Location *	LS
Category	Supplemental			GPS Latitude/Longitude	
				Start	End
Item	DWR UCIP Field Study			37.787929 °	37.787929 °
				-121.307173 °	-121.307173 °
DWR ID					
Comment Code					
Inspector Comment					
FS_ID:40707					
DS_ID:60					
EP_NO: 14326					
Repair Type: Non-Urgent					
Crossing Status: Indicator Found					
UCIP Comments: Wires exposed near levee crown unable to determine if these wires are part of the crossing. Need to contact owner to determine status of crossing.					
FIELD_STRUCT_DESC: 4 inch diameter communication cable through levee. Invert of conduit is 3.0 feet below levee crown. (Permit No. 14326-1986)					
FS Date: 2/4/2010

Overview of levee crown at crossing.

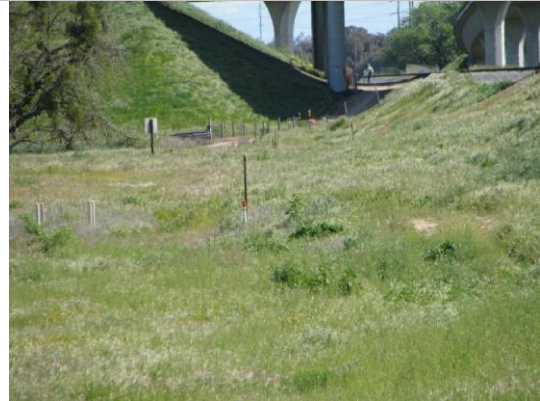
Photo 2 of 2 : UCIP_SP_2016_40707_72514.jpg

LM Start	12.55	Rating **	M	Issue No.	573 (cont)	
LM End	12.55	Issue Type +	En	Location *	LS	
Category	Supplemental			GPS Latitude/Longitude		
				Start	End	
Item	DWR UCIP Field Study			37.787929 °	37.787929 °	
				-121.307173 °	-121.307173 °	
DWR ID						
Comment Code						
Inspector Comment						
FS_ID:40707						
DS_ID:60						
EP_NO: 14326						
Repair Type: Non-Urgent						
Crossing Status: Indicator Found						
UCIP Comments: Wires exposed near levee crown unable to determine if these wires are part of the crossing. Need to contact owner to determine status of crossing.						
FIELD_STRUCT_DESC: 4 inch diameter communication cable through levee. Invert of conduit is 3.0 feet below levee crown. (Permit No. 14326-1986)						
FS Date: 2/4/2010

Crossing alignment along landward side.

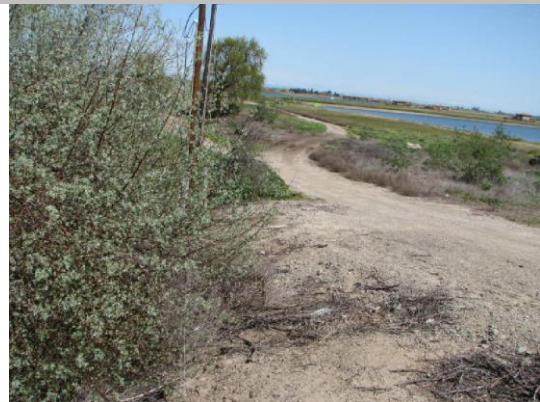
Photo 1 of 2 : UCIP_SP_2016_40712_72529.jpg

LM Start	13.26	Rating **	M	Issue No.	574
LM End	13.26	Issue Type +	En	Location *	LS
Category	Supplemental			GPS Latitude/Longitude	
				Start	End
Item	DWR UCIP Field Study			37.779653 °	37.779653 °
				-121.300064 °	-121.300064 °
DWR ID					
Comment Code					
Inspector Comment					
FS_ID:40712					
DS_ID:65					
EP_NO: 14450					
Repair Type: Non-Urgent					
Crossing Status: Found					
UCIP Comments: Need to contact owner to determine status of crossing.					
FIELD_STRUCT_DESC: 1 of 2: 18 inch diameter drainage discharge pipes through levee. (Permit No. 14450-1985)					
FS Date: 2/4/2010

View of landward side.

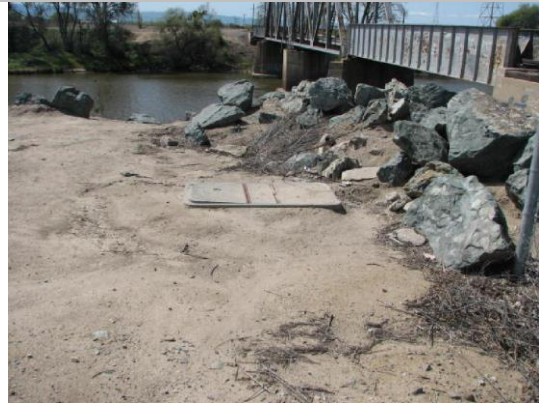
Photo 1 of 2 : UCIP_SP_2016_40713_72534.jpg

LM Start	13.26	Rating **	M	Issue No.	575
LM End	13.26	Issue Type +	En	Location *	LS
Category	Supplemental			GPS Latitude/Longitude	
				Start	End
Item	DWR UCIP Field Study			37.779643 °	37.779643 °
				-121.300057 °	-121.300057 °
DWR ID					
Comment Code					
Inspector Comment					
FS_ID:40713 DS_ID:287 EP_NO: 14450 Repair Type: Non-Urgent Crossing Status: Found UCIP Comments: Need to contact owner to determine status of crossing. FIELD_STRUCT_DESC: 2 of 2: 18 inch diameter drainage discharge pipes through levee. (Permit No. 14450-1985) FS Date: 2/4/2010

Precast concrete box located on levee shoulder.

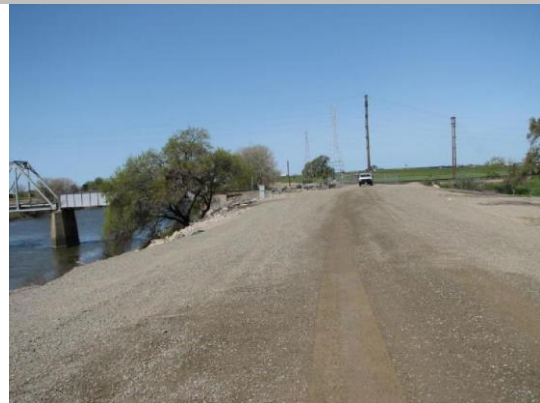
Photo 1 of 2 : UCIP_SP_2016_40714_72545.jpg

Comment Code						
Inspector Comment						
FS_ID:40714						
DS_ID:66						
EP_NO: 14467						
Repair Type: Non-Urgent						
Crossing Status: Found						
UCIP Comments: Records show this crossing was suppose to be abandoned however, the drain pipe was operable during site visit. Need to contact owner to clarify if crossing that was abandoned was removed and replaced with current crossing.						
FIELD_STRUCT_DESC: 36 inch concrete discharge gravity municipal waterwater discharge through levee approximatley 23 feet below crown. The reinforced concrete outfall structure with sluice gate will be constructed within the pipeline at the waterward levee shoulder. (Permit No. 14467-1986)						
FS Date: 2/4/2010

Overview of levee crown at crossing.

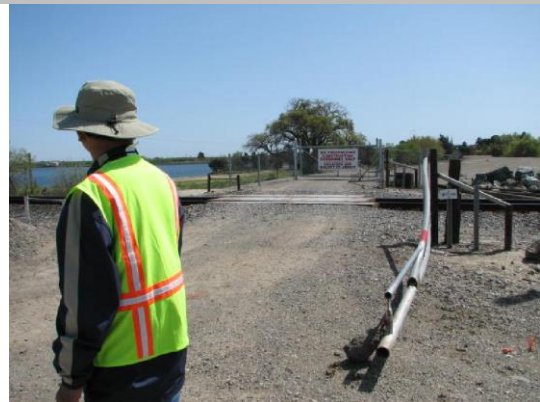
Photo 1 of 2 : UCIP_SP_2016_45995_72526.jpg

LM Start	13.28	Rating **	M	Issue No.	623
LM End	13.28	Issue Type +	En	Location *	LS
Category	Supplemental			GPS Latitude/Longitude	
				Start	End
Item	DWR UCIP Field Study			37.779470 °	37.779470 °
				-121.299954 °	-121.299954 °
DWR ID					
Comment Code					
Inspector Comment					
FS_ID:45995 DS_ID:67 EP_NO: N/A Repair Type: Non-Urgent Crossing Status: Indicator Found UCIP Comments: Markers visible on landward side only. Recommend contacting owner to confirm alignment and crossing. FIELD_STRUCT_DESC: Submarine power cable through the levee and across the channel. FS Date: 2/4/2010

View of levee crown at crossing.

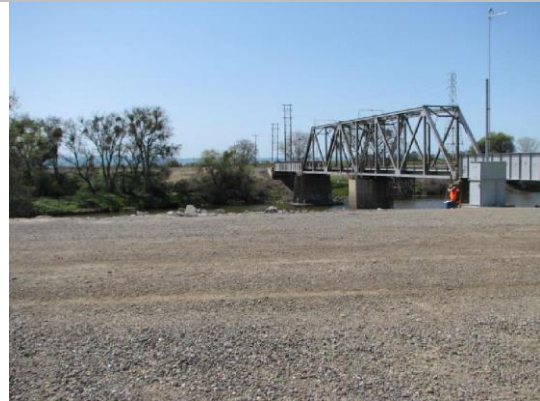
Photo 1 of 2 : UCIP_SP_2016_40715_72548.jpg

Comment Code					
Inspector Comment					
FS_ID:40715 DS_ID:809 EP_NO: N/A Repair Type: Non-Urgent Crossing Status: Found UCIP Comments: No information was obtained from desk study. This crossing was found during field visit. Need to contact owner to obtain additional details about crossing (installation date and permit) and status. FIELD_STRUCT_DESC: *ABANDONED* 18-inch pipe through the levee, 5.8 feet below the crown. Gate valve and siphon breaker on the waterward slope. Flap gate on the waterward end. One CM cutoff wall (Reclamation District No. 17 Drainage Plant). Pump on the landward side. Installed by USCE 1961. This entry matches the Drainage or Irrigation Structure referenced in O&M manual (HLM 13.36). (USACE O&M, 1963). Welded Steel plate installed over one end of pipe under Permit No. 14450, 1988. FS Date: 2/4/2010

View of levee crown at crossing.

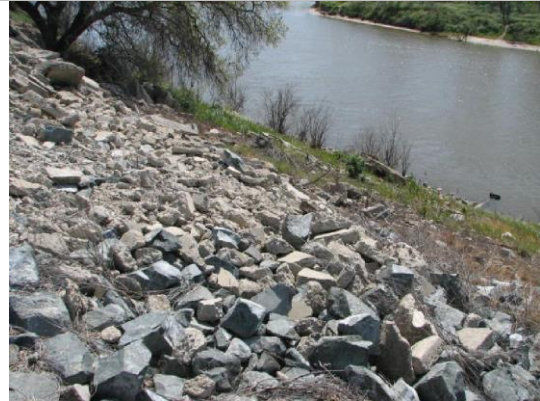
Photo 2 of 2 : UCIP_SP_2016_40715_72551.jpg

Comment Code					
Inspector Comment					
FS_ID:40715 DS_ID:809 EP_NO: N/A Repair Type: Non-Urgent Crossing Status: Found UCIP Comments: No information was obtained from desk study. This crossing was found during field visit. Need to contact owner to obtain additional details about crossing (installation date and permit) and status. FIELD_STRUCT_DESC: *ABANDONED* 18-inch pipe through the levee, 5.8 feet below the crown. Gate valve and siphon breaker on the waterward slope. Flap gate on the waterward end. One CM cutoff wall (Reclamation District No. 17 Drainage Plant). Pump on the landward side. Installed by USCE 1961. This entry matches the Drainage or Irrigation Structure referenced in O&M manual (HLM 13.36). (USACE O&M, 1963). Welded Steel plate installed over one end of pipe under Permit No. 14450, 1988. FS Date: 2/4/2010

View of waterward side, photo 1 of 2.

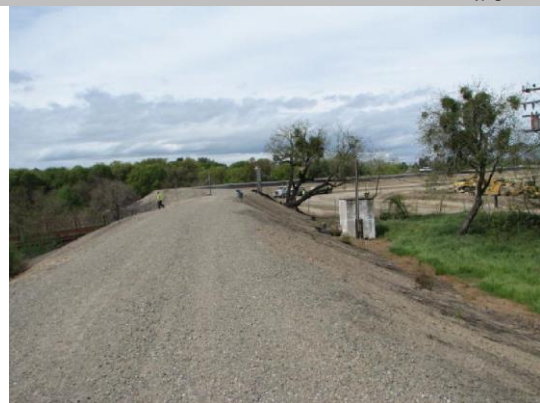
Photo 1 of 2 : UCIP_SP_2016_40716_72557.jpg

LM Start	14.20	Rating **	M	Issue No.	578
LM End	14.20	Issue Type +	En	Location *	LS
Category	Supplemental			GPS Latitude/Longitude	
				Start	End
Item	DWR UCIP Field Study			37.772267 °	37.772267 °
				-121.290202 °	-121.290202 °
DWR ID					
Comment Code					
Inspector Comment					
FS_ID:40716 DS_ID:69 EP_NO: 15165 Repair Type: Non-Urgent Crossing Status: Found UCIP Comments: Pump was working during the survey. Levee toe erosion at waterward side. Recommend contacting owner to determine status and to evaluate erosion at waterward toe. FIELD_STRUCT_DESC: 20-inch pipe through the levee, 1.7-feet below the crown. Pump on pile structure in the stream. Wooden walkway to the pump. concrete distribution box at the toe of the landward slope. (Permit No. 15165-1989) FS Date: 2/4/2010

Overview of levee crown at crossing.

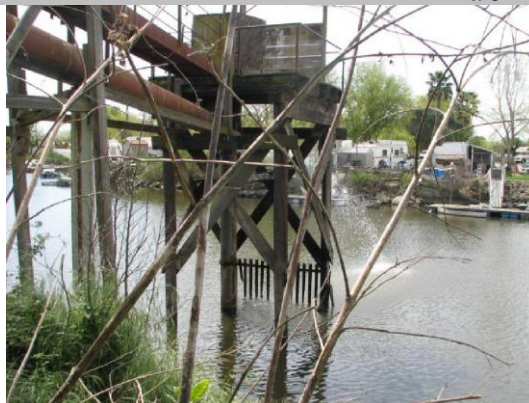
Photo 2 of 2 : UCIP_SP_2016_40716_72556.jpg

LM Start	14.20	Rating **	M	Issue No.	578 (cont)	
LM End	14.20	Issue Type +	En	Location *	LS	
Category	Supplemental			GPS Latitude/Longitude		
				Start		End
Item	DWR UCIP Field Study			37.772267 °		37.772267 °
				-121.290202 °		-121.290202 °
DWR ID						
Comment Code						
Inspector Comment						
FS_ID:40716 DS_ID:69 EP_NO: 15165 Repair Type: Non-Urgent Crossing Status: Found UCIP Comments: Pump was working during the survey. Levee toe erosion at waterward side. Recommend contacting owner to determine status and to evaluate erosion at waterward toe. FIELD_STRUCT_DESC: 20-inch pipe through the levee, 1.7-feet below the crown. Pump on pile structure in the stream. Wooden walkway to the pump. concrete distribution box at the toe of the landward slope. (Permit No. 15165-1989) FS Date: 2/4/2010

Pipe operable during survey.
